This spreadsheet performs screening level calculations to estimate the effect of peeling leaded paint on the average concentration of lead in yard soil
1828 36th Avenue

Property ID: 390	Date: 8-18-05
Address: 1828 36TH AVE	Telephone #:
Owner:	CO Certification #: 12860
Inspector/Assessor:

LBP Assessments Results

SITE NAME: VASQUEZ BOULEVARD AND I-70

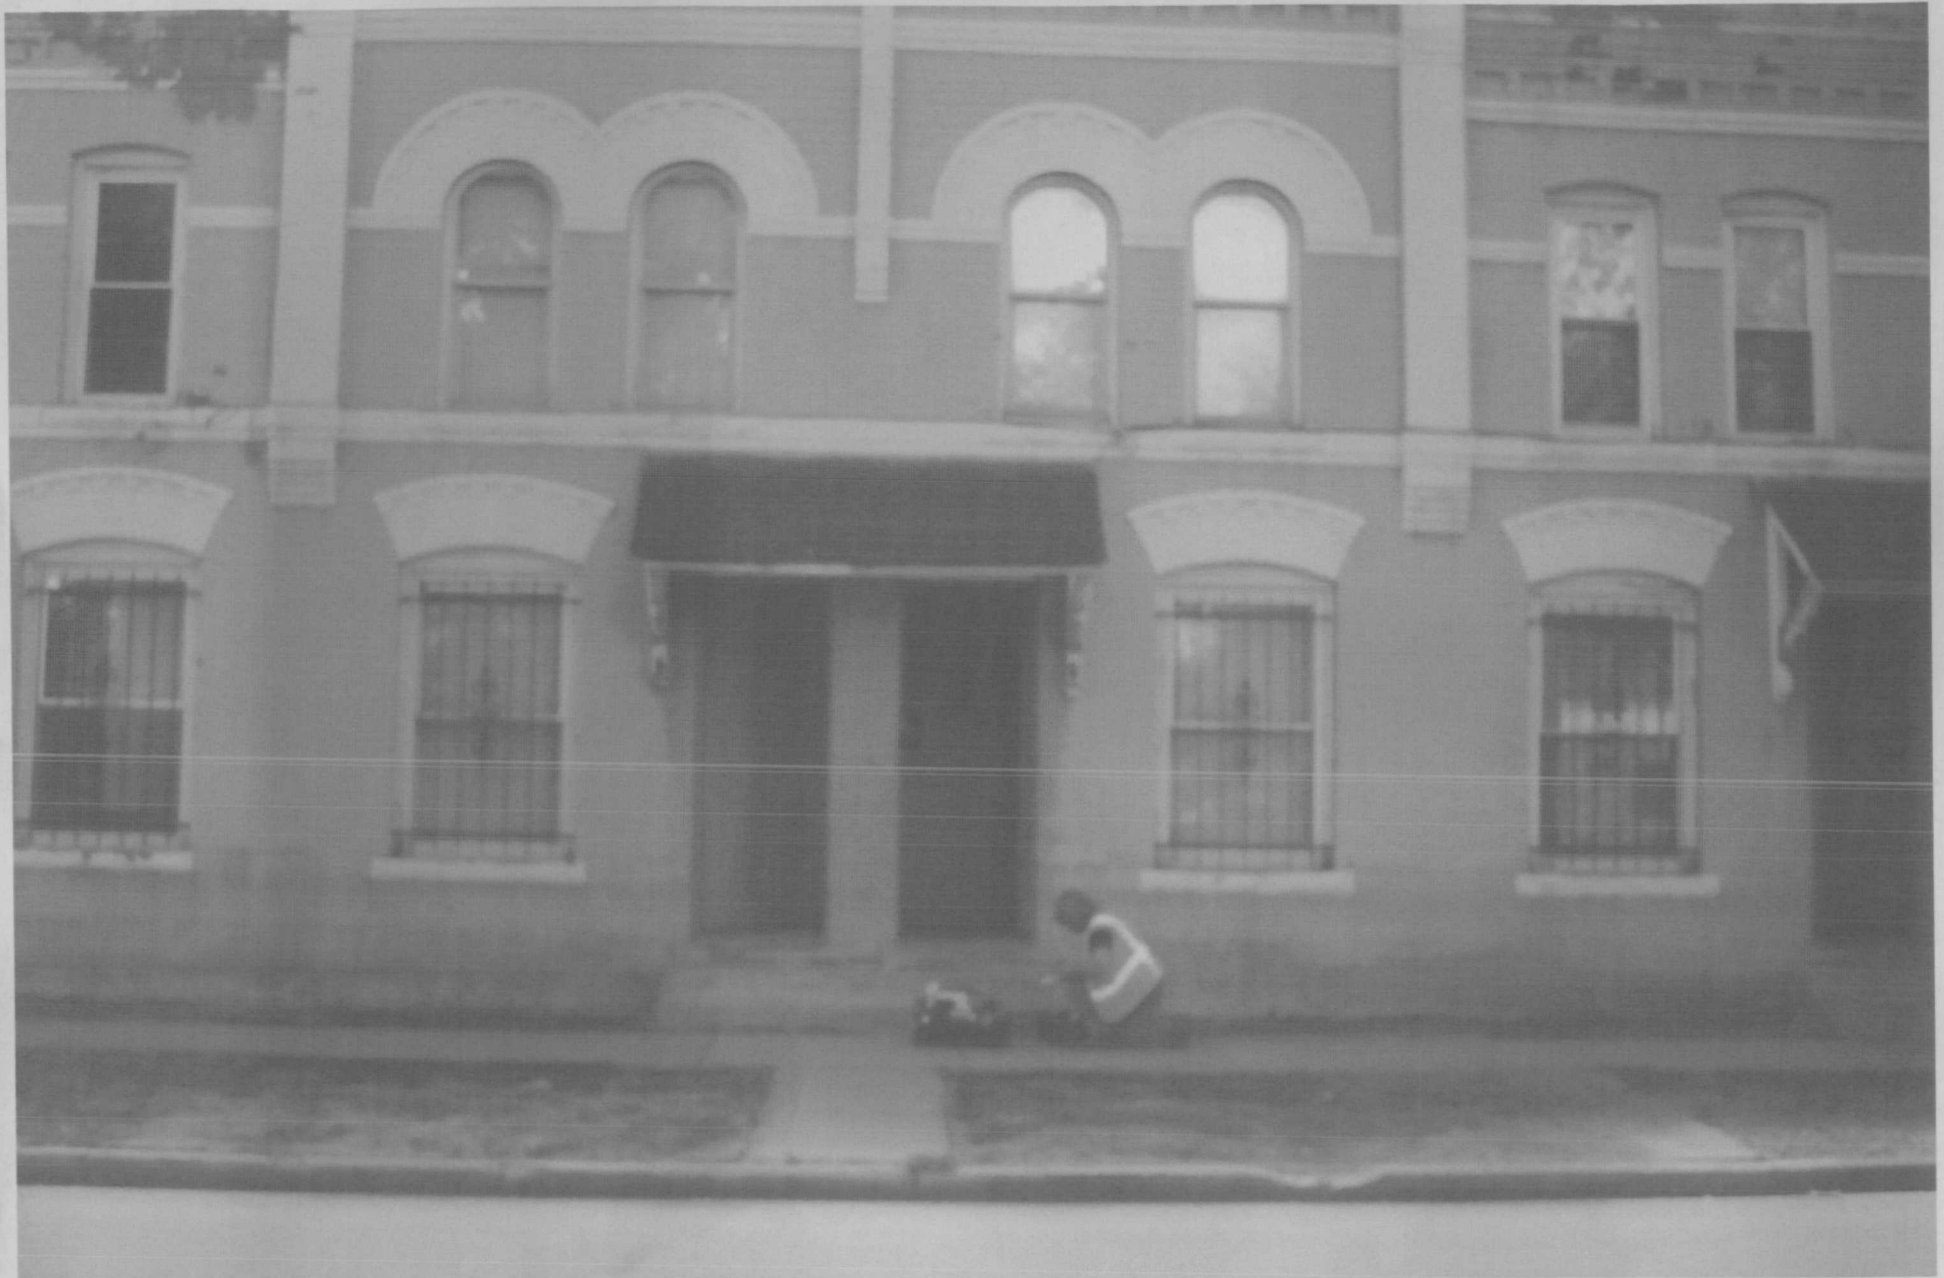
Property ID # 390 / 1828 36th Ave.

North exposure windows & porch trim contain peeling lead paint
